State of California — The Resources Agency
DEPARTMENT OF PARKS AND RECREATION
PRIMARY RECORD

*Resource Name or #: K30

c. Address 8673 Salmon Avenue

*P3a. Description: This property includes three small residences. The unpaved lot is used as an informal trailer park. The trailers, though mainly recreational, are used as long-term residences. Some native trees survive on the lot. (continued)

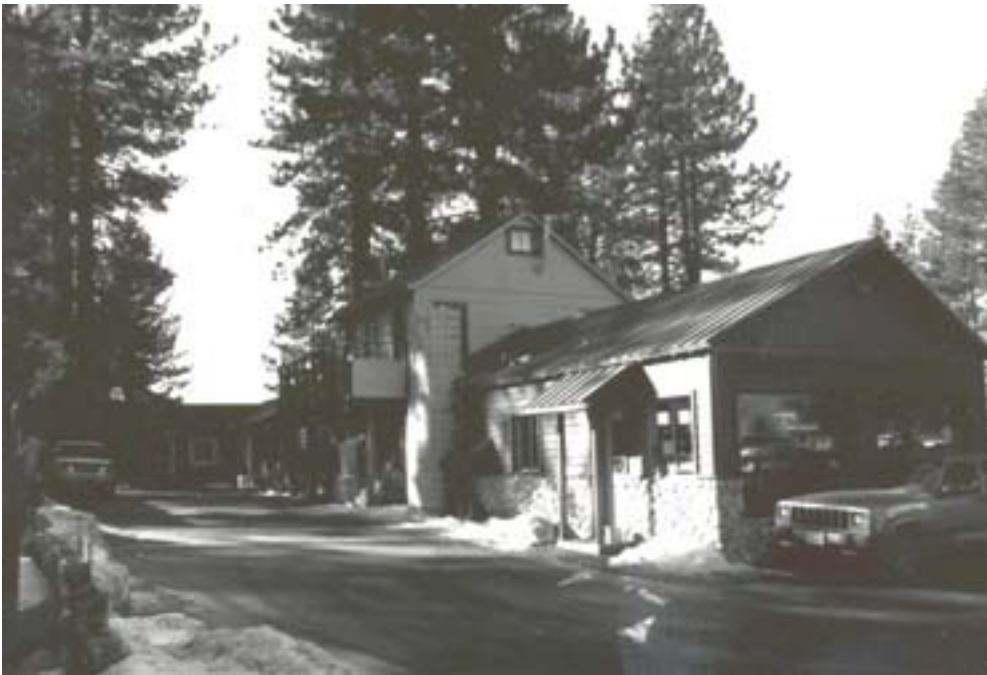
***P3a. Description:** This property includes two buildings on a paved lot. No native trees grow on the lot. Building A is a rectangular plan structure with a side gable roof clad with recent standing seam metal panels. The front (north) half of the building is one-story, occupied by the video store. It is of straight corner cinderblock construction sheathed with wood lap and V-rustic siding, along with cobble veneer wainscot. Windows are fixed and metal sliders, metal 1/1 double-hung, and wood 1/1 double-hung. Doors are one light panel. The rear (south) half of the building is 2½ story wood frame, occupied by apartments. Siding includes board and batten on the gable end. Windows are 1/1 metal double-hung, metal sliding, and fixed. Doors are flush. Building B is a rectangular L-plan wood frame house. The roof is cross gable with open eaves and exposed rafters, clad with rolled composition material with a dog-tooth edge to simulate shingles. A plastic sheet was secured over the roof with battens, but the plastic has decayed and been blown away. Walls are sheathed with wood lapped and V-rustic siding. Plywood skirting covers the foundation. Windows are 1/1 and 2/2 wood double-hung and two aluminum sliders. Doors are wood panel with one light. It appears that the east wing was added to the original structure, but this addition appears to date to the 1950s.

P5b. Description of Photo:
090-134-002, Building A, View SW.
Roll KBB7, Fr. 1. 01-20-03, 10:15 AM.

*B6. Construction History: Assessor does not have dates for the buildings. A building is shown in this location on the 1955 USGS map. Modifications (c.1990s) to Building A include a new addition, siding, windows, doors, and roofing. Modifications (c.2000s) to Building B include foundation skirting, windows, trim, and roof battens.

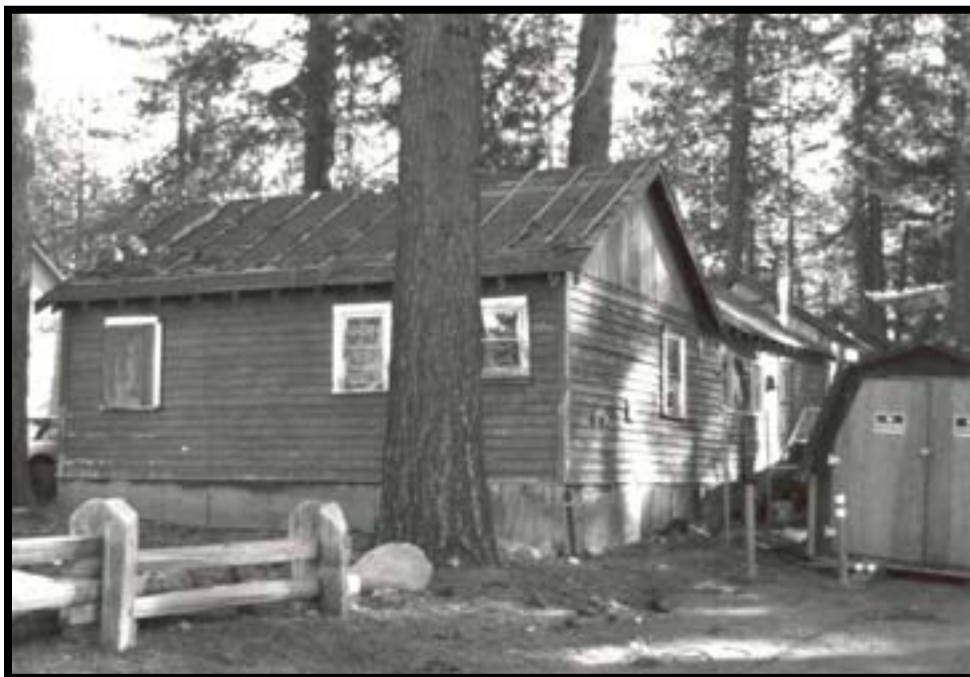
090-134-002, Building B, View NE.
Roll KBB7, Fr. 0. 01-20-03, 10:10 AM.

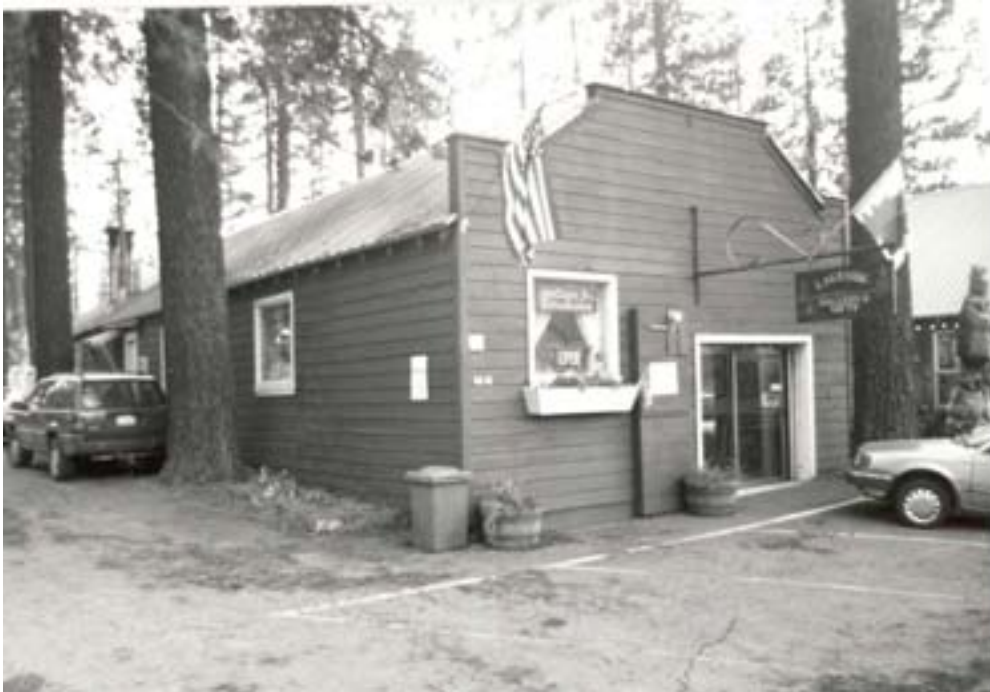
Building A is a one-story rectangular plan wood frame store presently occupied by the Lakeside Gallery and Gifts. It has a jerkin-head roof with false front, open eaves, and exposed rafters, clad with recent metal panels. Walls are sheathed with wood drop rustic siding. Windows are wood 6/6 double-hung and recent fixed. Doors are recent metal sliders. (continued)

P5b. Description of Photo:
090-134-005, Building A, View SW.
Roll KBB4, Fr. 11. 11-14-02, 3:36 PM.

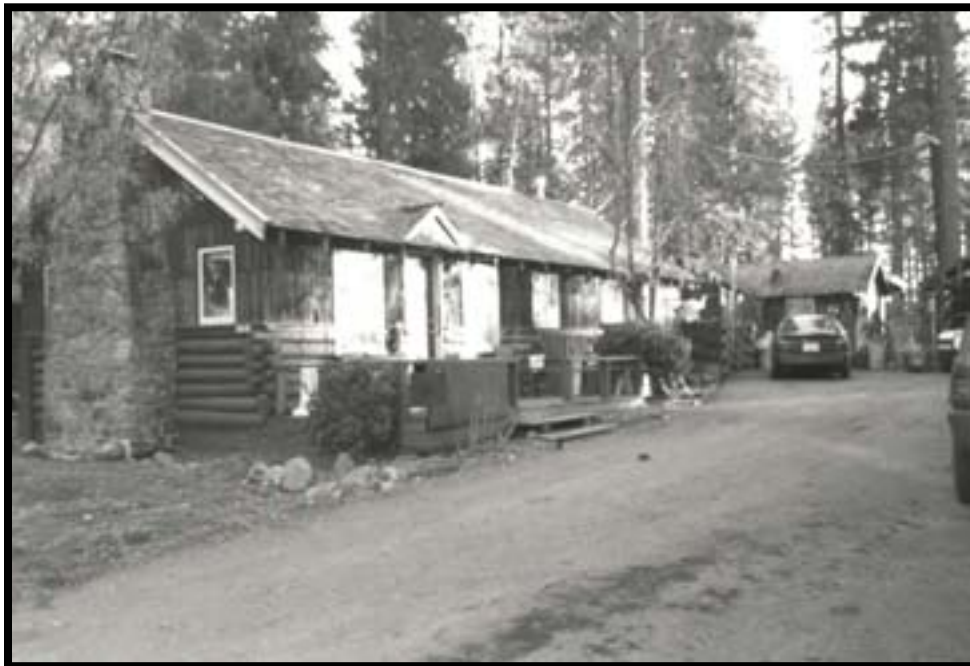
090-134-005, Building B, View SE.
Roll KBB4, Fr. 12. 11-14-02, 3:37 PM.

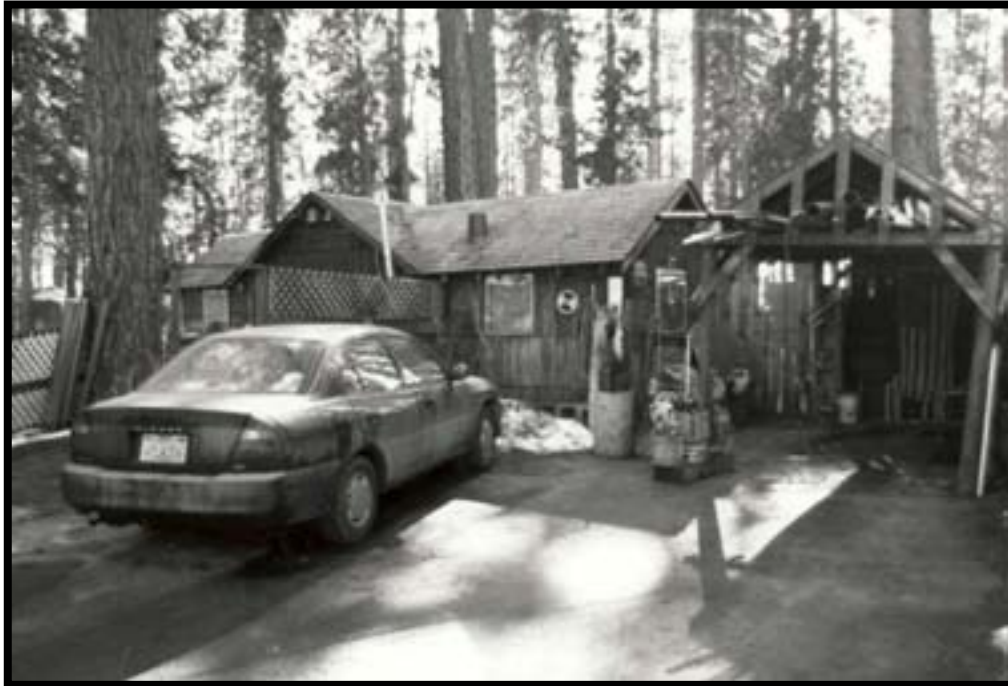
Associated with Building C is an end-gable carport. The roof is supported on round wooden posts.

090-134-005, Building C left, carport right. View S.
Roll KBB7, Fr.3 01-20-03, 11:55 AM.

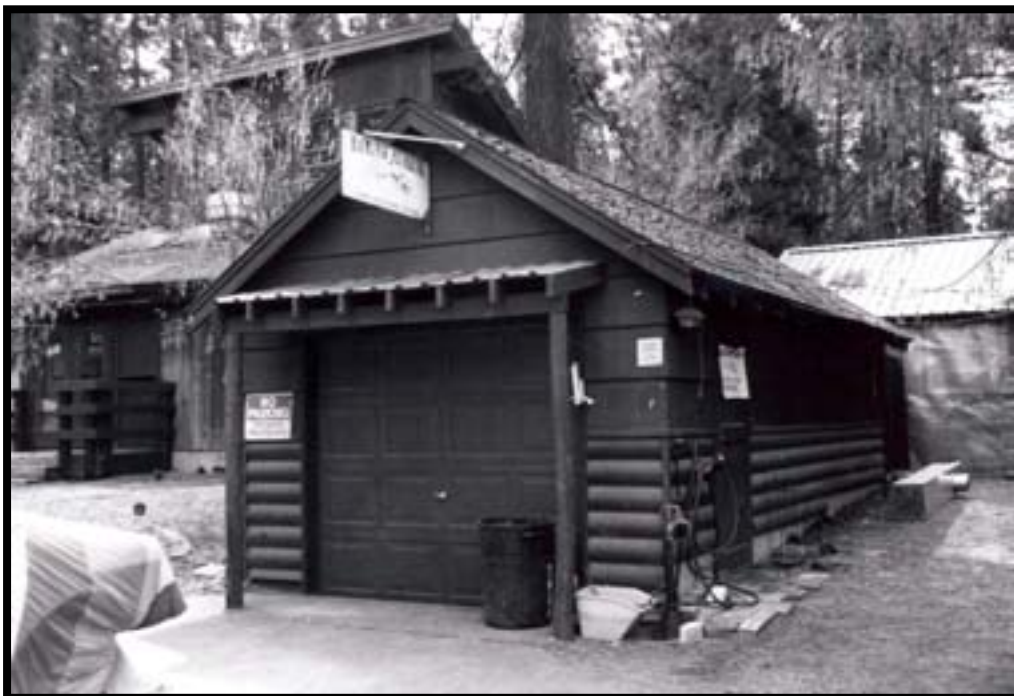
090-134-005, Garage, View SE.
Roll KBB11, Fr.8. 04-01-03, 11:40 AM.

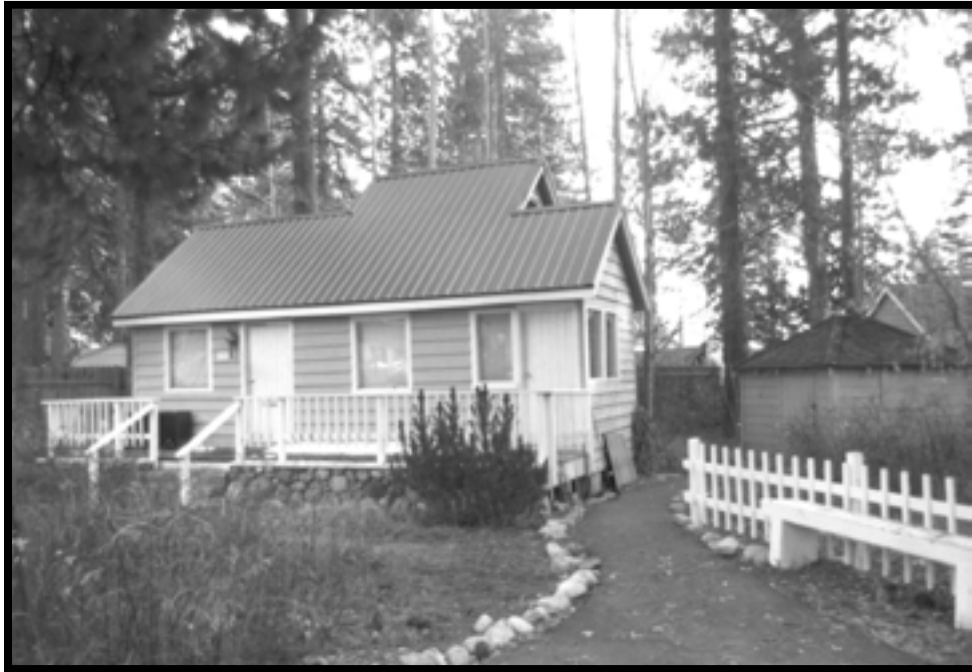
090-134-030, Building B, View E.
Roll KBB4, Fr.14. 11-14-02, 3:50 PM.

Building B is a 1½-story rectangular plan wood frame house. It has a side gable roof with open eaves and fascia, clad with standing seam metal roofing. Walls are sheathed with wood lap siding. All visible windows are fixed single light. The door is clad with wood V-rustic siding. An open porch with simple railings and cobble foundation extends the width of the main facade

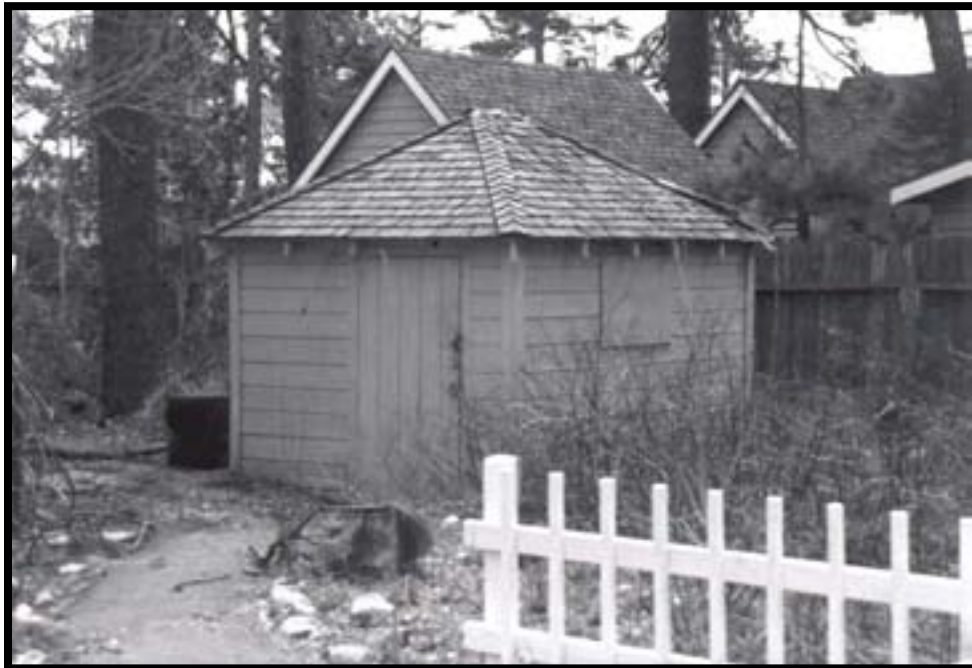
090-134-030, Pump House, View SE.
Roll KBB11, Fr.9. 04-01-03, 11:40 AM.

Adjacent to Building B is what appears to be a pump house. It is one-story, rectangular in plan, and of wood frame construction. It has a hip roof with open eaves and exposed rafters, clad with milled wood shingles. Walls are low and sheathed with wood V-rustic siding, as is the door. The window has been boarded over.

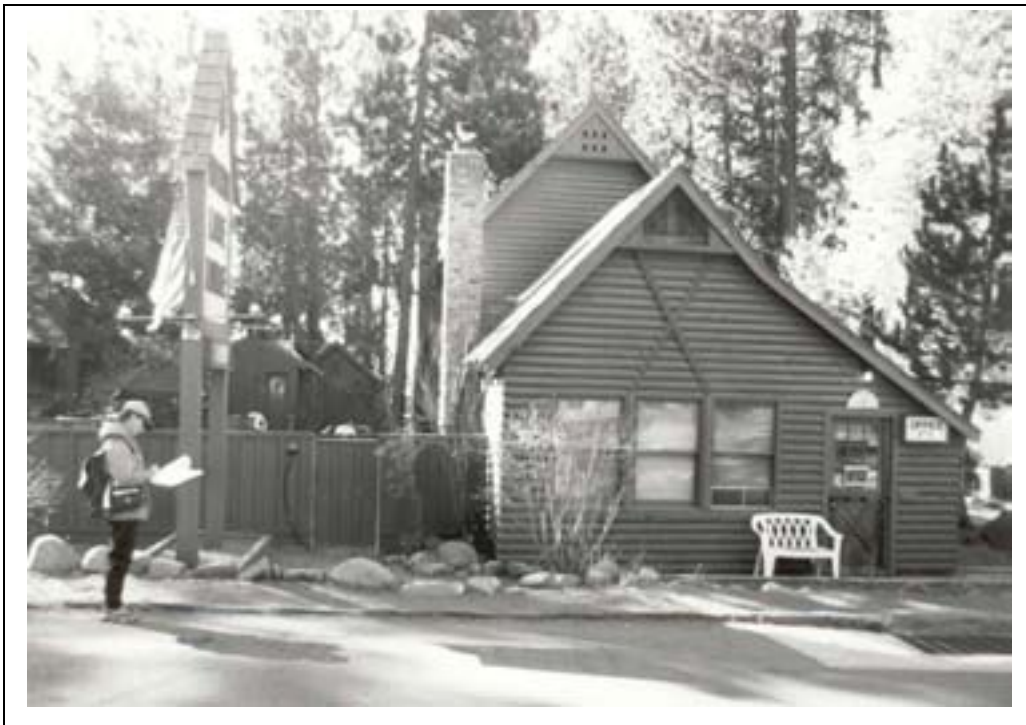
P5b. Description of Photo:
090-142-001, View South.
Roll KBB1, Fr.9. 10-30-02, 10:10 AM.

***P3a. Description:** This property is presently part of the North Lake Lodge, which includes the lots to the east and south. Portions of the lots not used for parking support native trees. The building is a two-story rectangular plan wood frame motel. It has a gable roof with open eaves and exposed rafters, clad with composition shingles. Walls are clad with stained log cabin siding. Windows are wood 1/1 double-hung and wood sliding. Four windows have been replaced with metal sliders. Doors are recent X-panel with lights. There appear to have been several additions, but all appear historic. The building has two brick fireplaces, of which the northern one appears recent. The building has a large open porch. Recent lattice has been added to the railings.

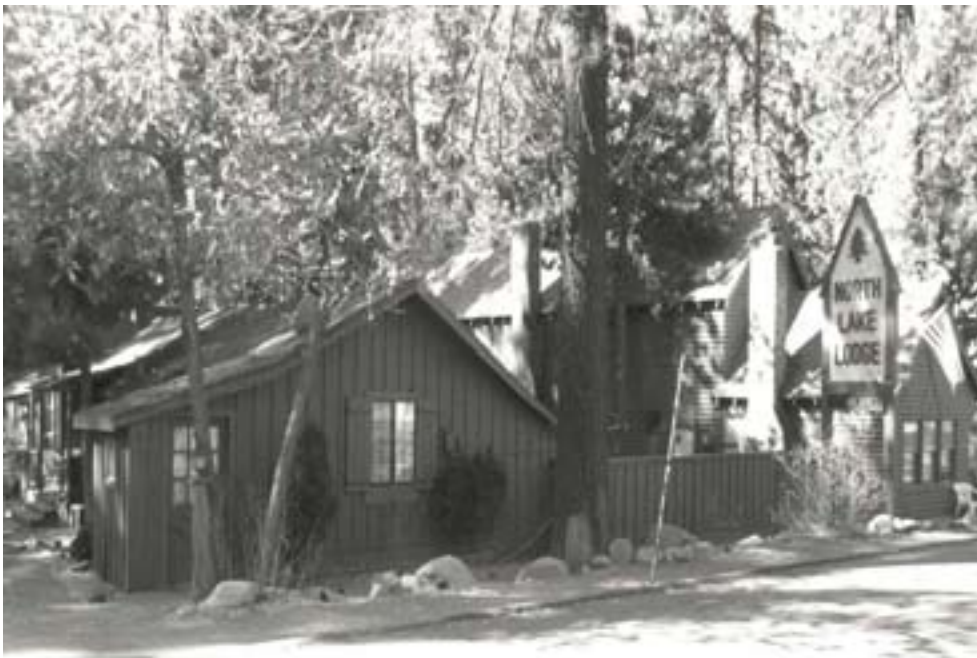
P5b. Description of Photo:
090-142-002, Building A, View SW.
Roll KBB1, Fr.8. 10-30-02, 10:05 AM.

Building A is a one-story building with multiple rental units. It has a complex plan due to several additions linking what appear to have been several previously separate buildings. It has a cross-gable roof with open eaves and fascia, clad with composition shingles. The walls are sheathed with stained board and batten siding except for plywood T1-11 on the south end. Windows include wood casement with various numbers of lights, metals sliders and metal 1/1 double-hung. Doors include V-rustic, panel, and flush with two lights. Recent (c. 1990s) doors are X-panel with lights. A porch has been added. (continued)

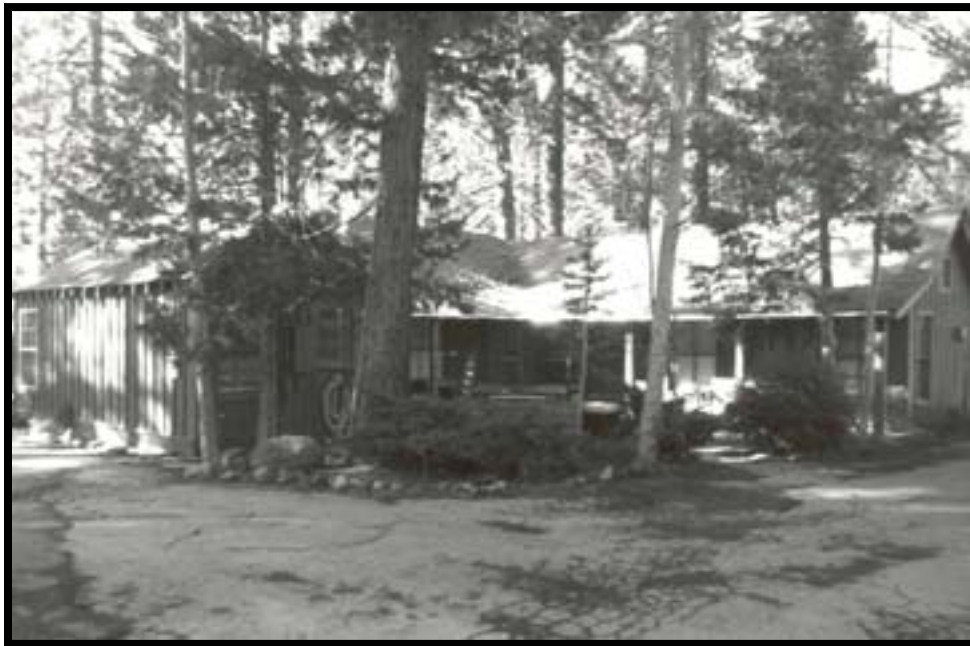
090-142-001, Building B, View SW.
Roll KBB7, Fr.17. 01-20-03, 10:50 AM.

Building B is a one-story L-plan wood frame building housing three rental units. It has a cross-gable roof with open eaves and exposed rafters, clad with composition shingles. Walls are sheathed with stained board and batten siding. Windows are six light wood casement and wood 1/1, 2/2, and 4/4 double-hung. Doors are panel. One window has been equipped with a metal storm window. There do not appear to be any other recent modifications.

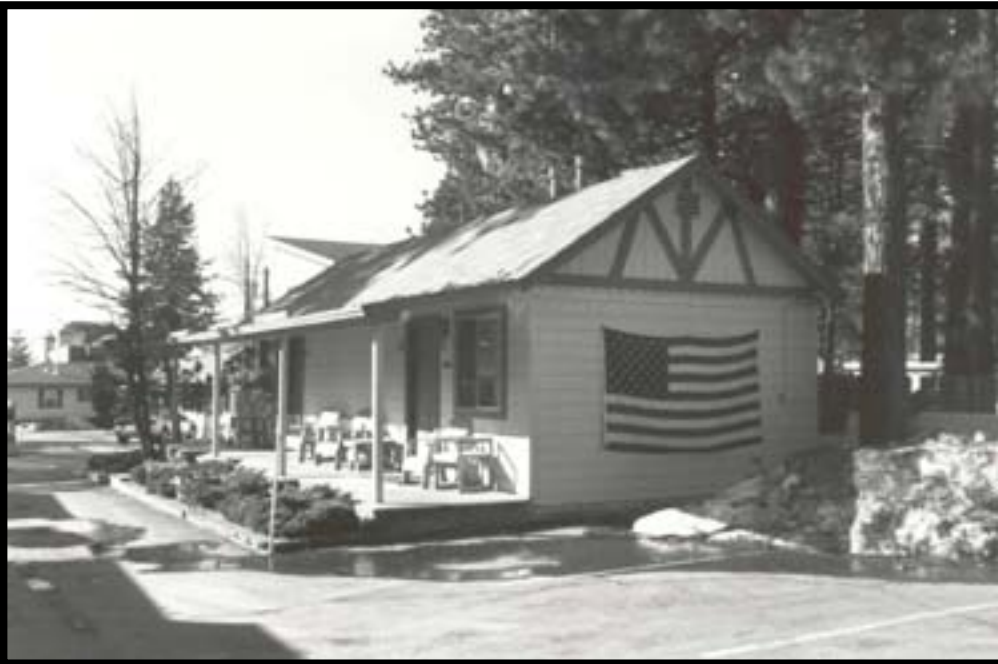
Building B, View SW.

Building B is a one-story rectangular plan wood frame building. It has a side gable roof with open eaves and gable ends partly covered by a recent fascia. A recent porch supported by simple posts extends along the entire east side of the building. Walls are sheathed with painted wood V-rustic siding. Recent contrasting trusswork trim has been added to the gable end. Windows are aluminum sliders and the doors are recent flush. A small shed has been added to the south end of the building.

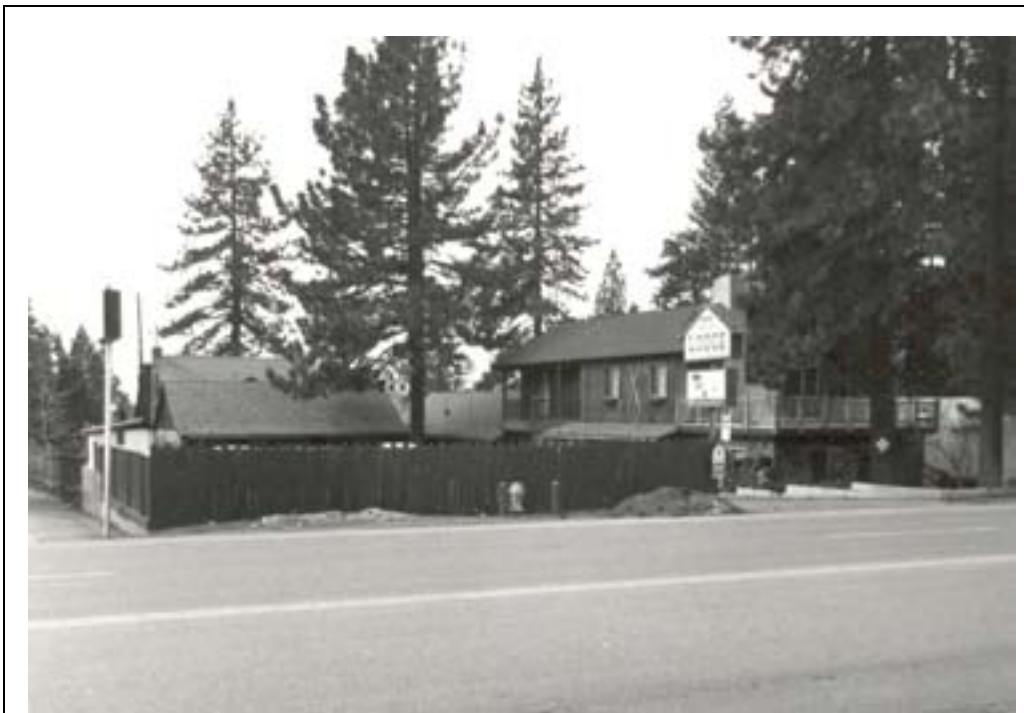
090-142-026, View SW.

***P3a. Description:** This building is a one and two-story L-plan cinder block motel. As originally built, it was one-story with all walls made of cinder blocks with rounded corners. It has a gable roof with open eaves and exposed rafters, clad with composition shingles. Gable ends are clad with stained wood V-rustic siding. Original windows are metal casement, but many have been replaced with aluminum sliders. Doors are flush. The entire second story is a gabled addition, clad with plywood T1-11 siding. It has aluminum sliding windows and patio doors and a cinder block chimney. At the north end of the building is a second addition. This is one-story with a flat roof that doubles as a deck. It has milled shingle siding, aluminum sliders, and peeled log railings. A third addition is a shed-roofed enclosed entry porch. The original porch above entries all along the rear of the building is supported by pillars made of rounded-corner cinder blocks. There is a concrete pool at the northeast corner of the property. Cinderblock and cobble retaining walls and planters have been added. A few native trees survive at the rear of the lot. The sign is recent (c.1990s).

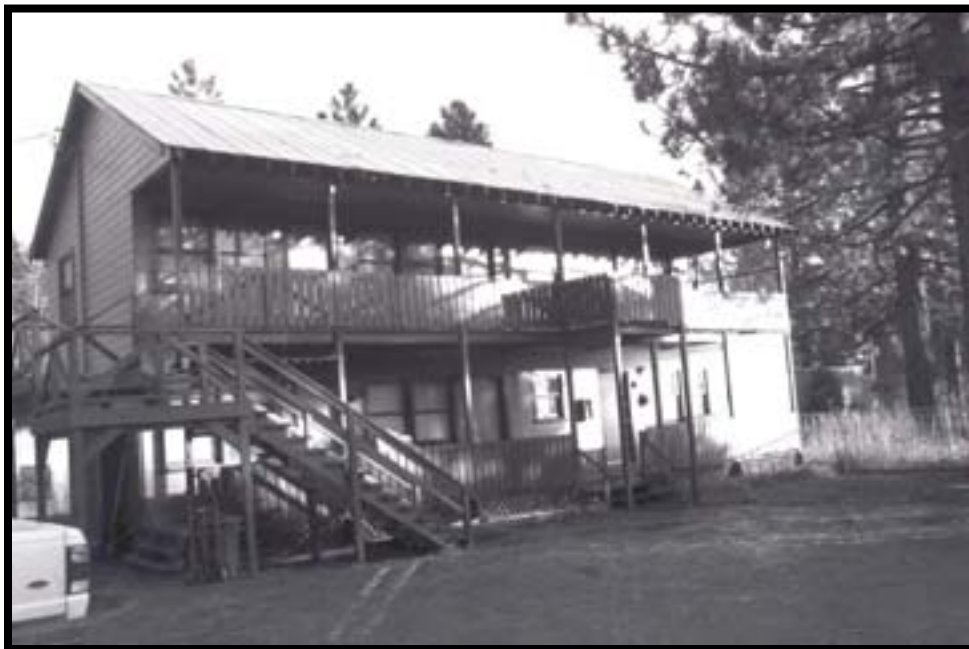
090-142-007 Building B, View SE.
Roll KBB4, Fr.16. 11-14-02, 3:55 PM.

Building B is a two-story rectangular plan wood frame apartment building. It has a side-gable roof with exposed rafters and open eaves, clad with recent aluminum panels. The building has a full-length covered porch supported by simple posts with vertical board railing. Walls are clad with painted wood lap and V-rustic siding. Windows are wood 1/1 double-hung, some of which are covered with metal storm windows or temporary plastic sheets.

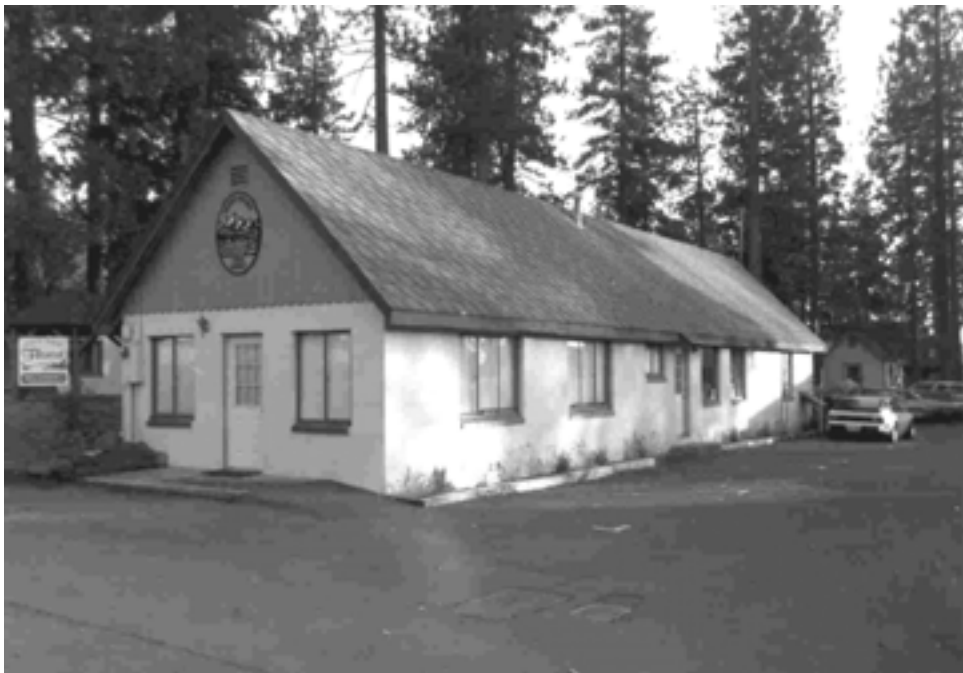
090-221-018, View SE.

***P3a. Description:** This building is a one-story rectangular commercial structure made of rounded-corner cinder block. It has a gable roof with open eaves and fascia clad with locking composition shingles over an older layer of standard tab composition shingles. Walls are unsheathed block except for the gable ends, which are of painted wood V-rustic siding. Windows are steel 2 and 3 light casement. The door is panel with lights. A metal exterior chimney has been added. The entire lot is paved.

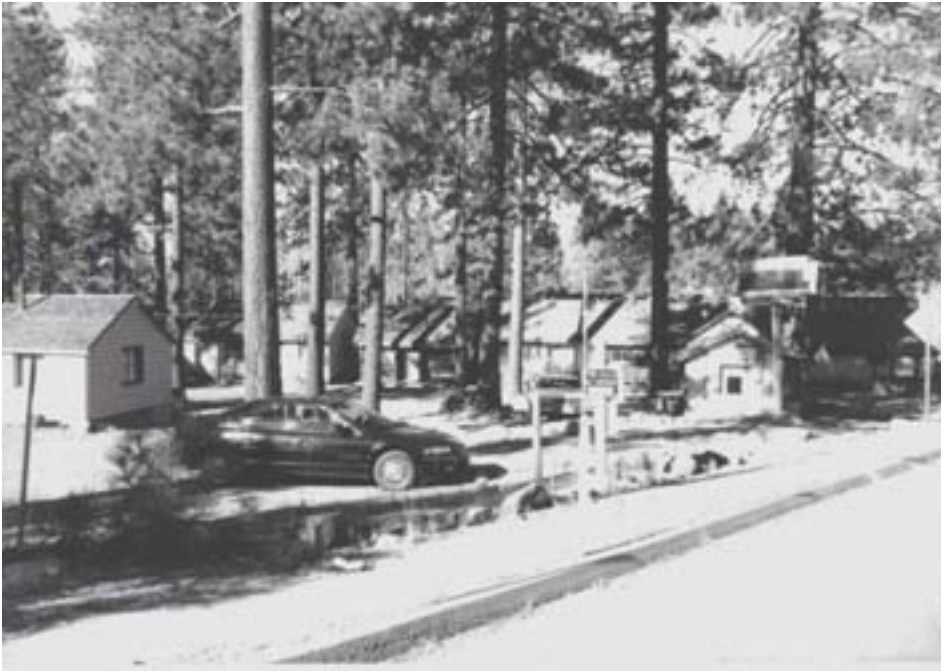
P5b. Description of Photo:
Overview from SR 28, facing SW.
KBB1 Frame 2

The Brockway Pines Motel was an auto court consisting of at least 7 small rustic cabins arranged around a central parking area.

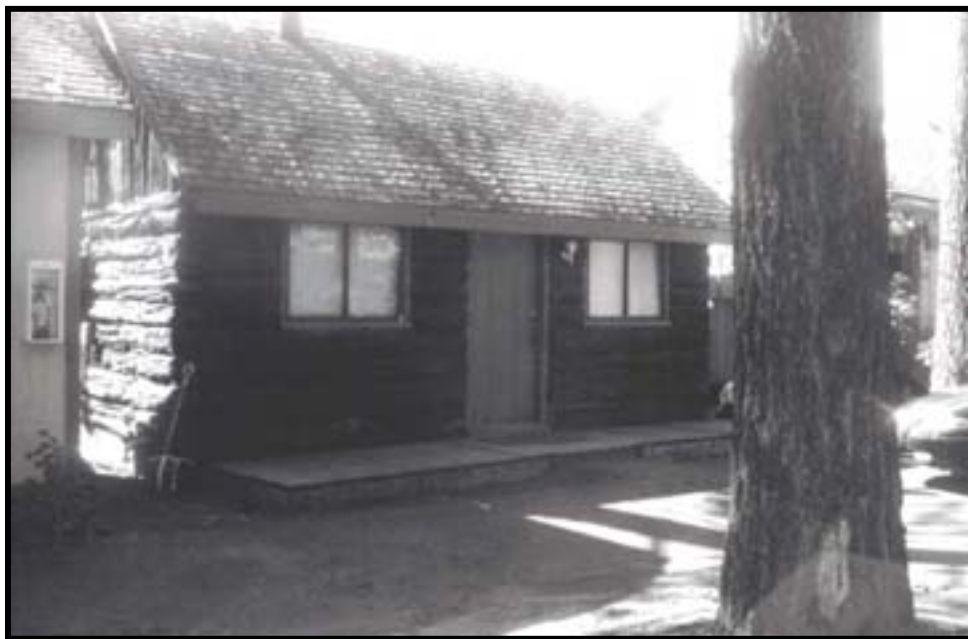
Building B (Front), View NW, KBB13, Fr. 24,

Building B is a one-story wood frame house matching the description for the north half of Building A except that the windows have been replaced with metal sliders.
